North San Joaquin Water Conservation District
Operations Update

Saturday, June 20, 2026

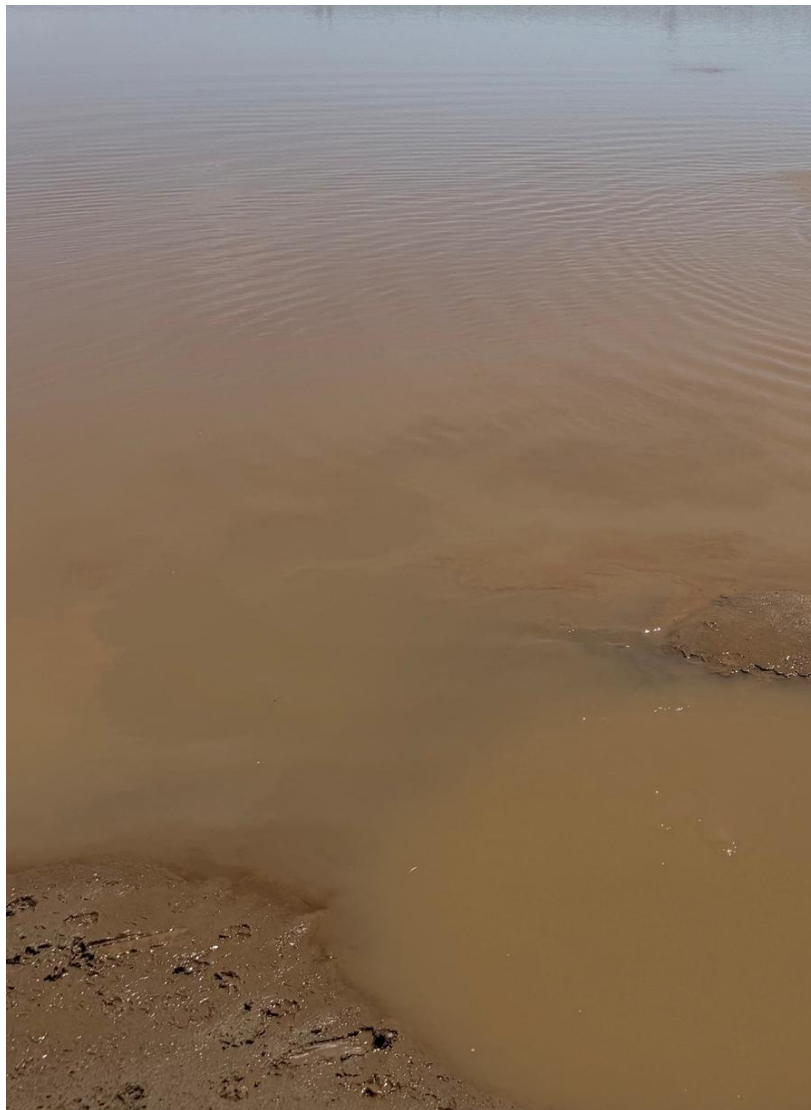
Tecklenburg Basin: Staff pumped teck basin into the south road until the basin got to shallow for the intake. We then started pumping the east basin into the west. Unfortunately, we discovered that an old low head line connects the two sides undermining our pumping efforts. We plugged the deepest line with towels and an old piece of PVC and the shallower one with a bike tube. The Pump is not moving water to the west much faster with less than three inches remaining in the east basin

Boils coming from an old low head line foil efforts to drain the East Basin

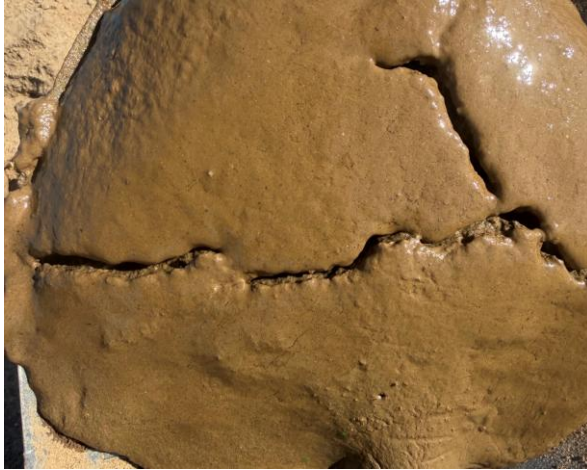
Teck basin is very silty on the top two millimeters. The surface feels like the consistency of potting clay and is very different from Lakso which continues to look very sandy.

Teck Clay Surface

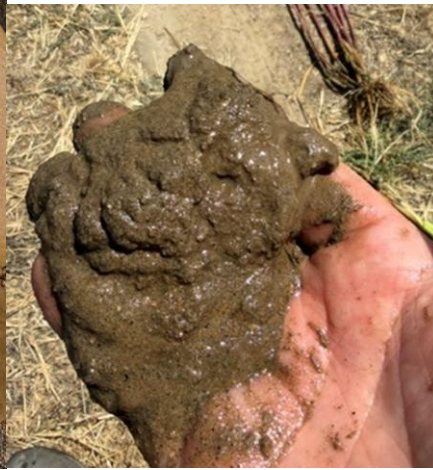
Lakso sandy Surface

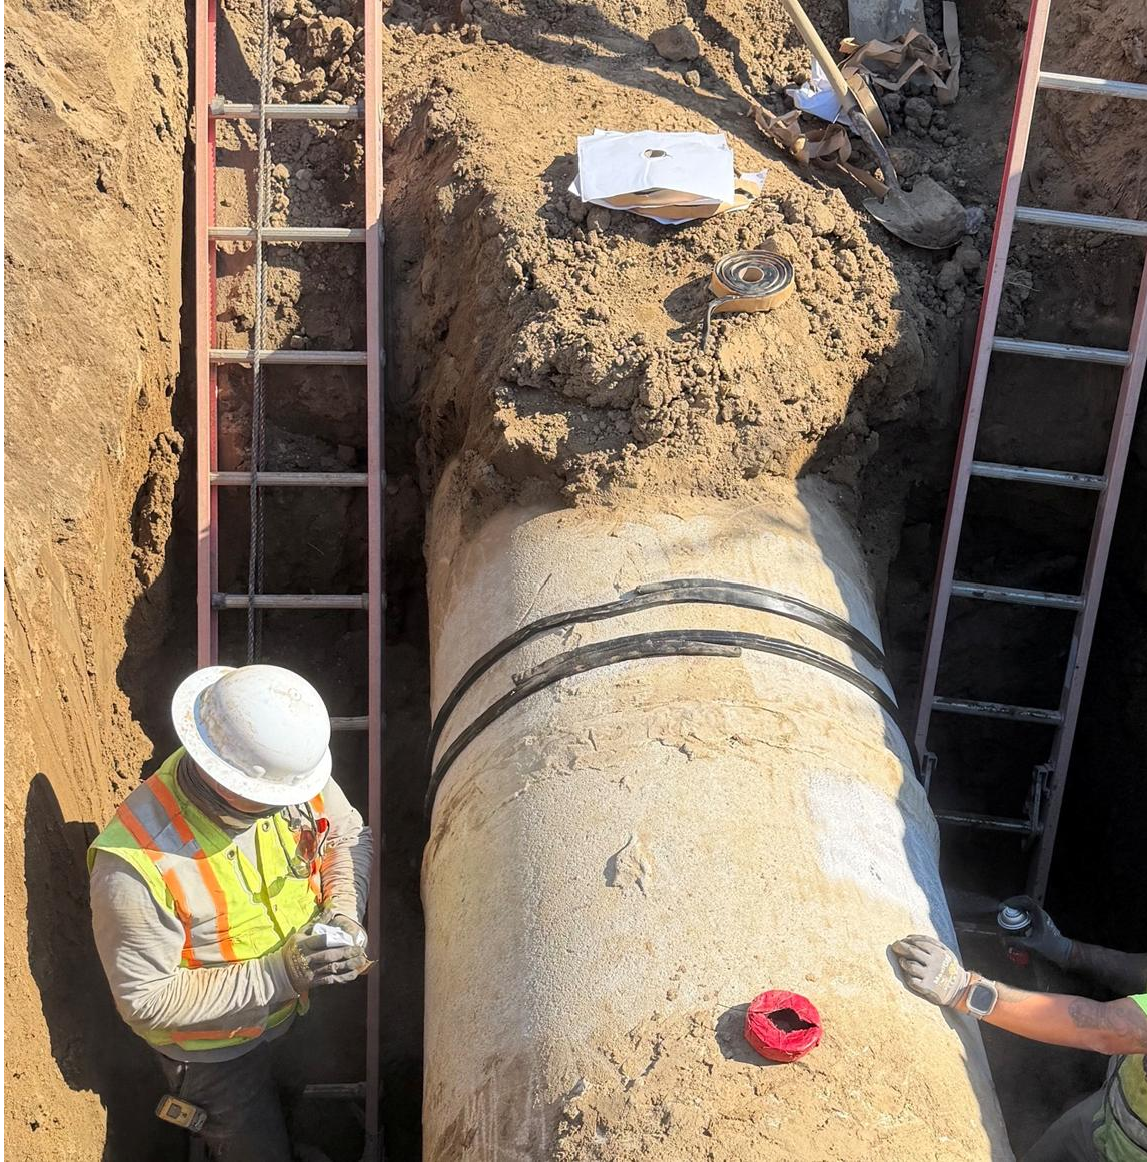
South System Work: Arnaudo poured collars around the Tretheway leaks on the south main. Unfortunately, when they attempted to enter the East Ditch Lateral for those repairs they encountered heavy sand deposits the length of the lateral as it runs through the Brandt Road extension. They also found heavy concrete deposits holding sand in the pipe just a few feet in from the East Ditch Outfall. Arnaudo plans to expose the two vents to inspect the sand conditions on the main section of Brandt Road and remove the debris at the bottom end of the pipeline. Then we will run the lateral and see if we can clean some of the sand out of the way. If the sand has to be removed with a vac con truck it will be quite expensive. If we are going to incur that expense, we should probably consider lining the pipe now as it leaks too badly to allow above ground farming operations. We hope to have some information on lining costs and options for the Board at its June 29 meeting.

SS Main Repairs on Tretheway

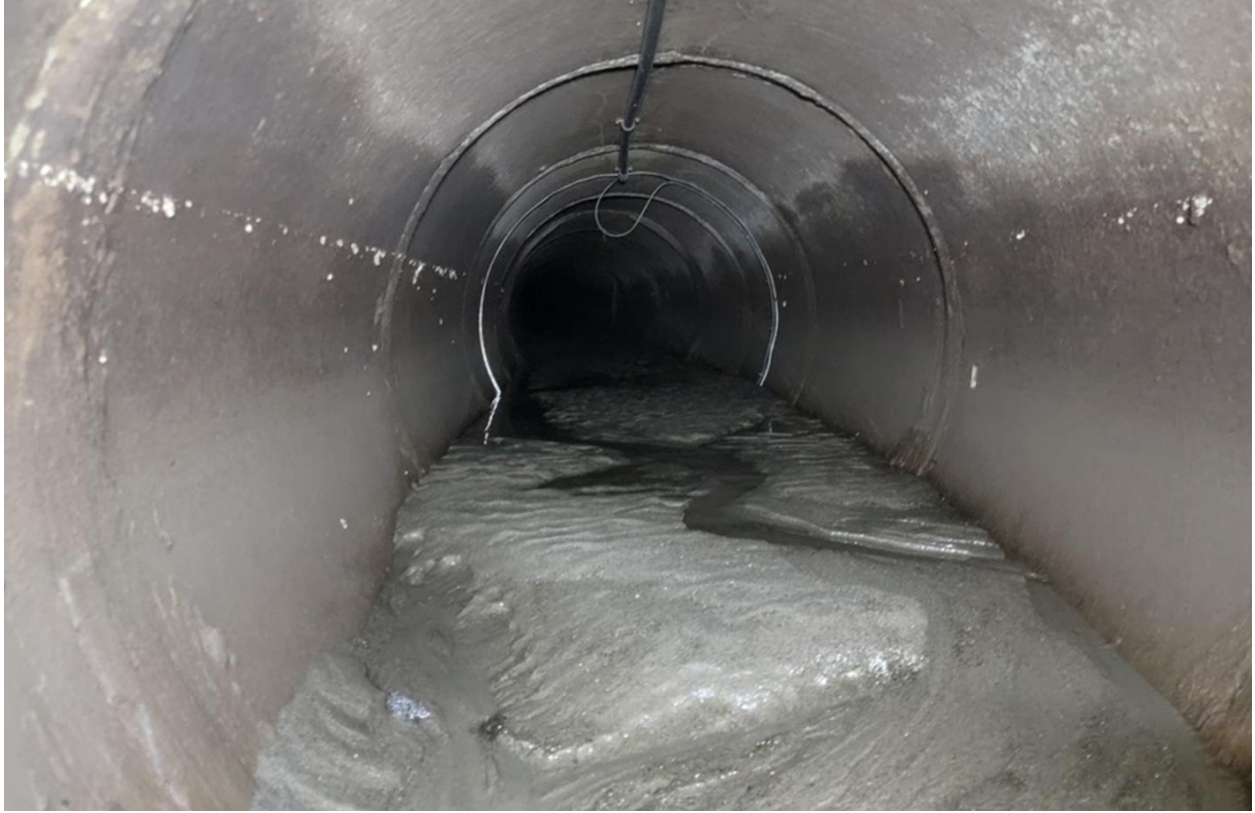
Brandt Road Extension Lateral

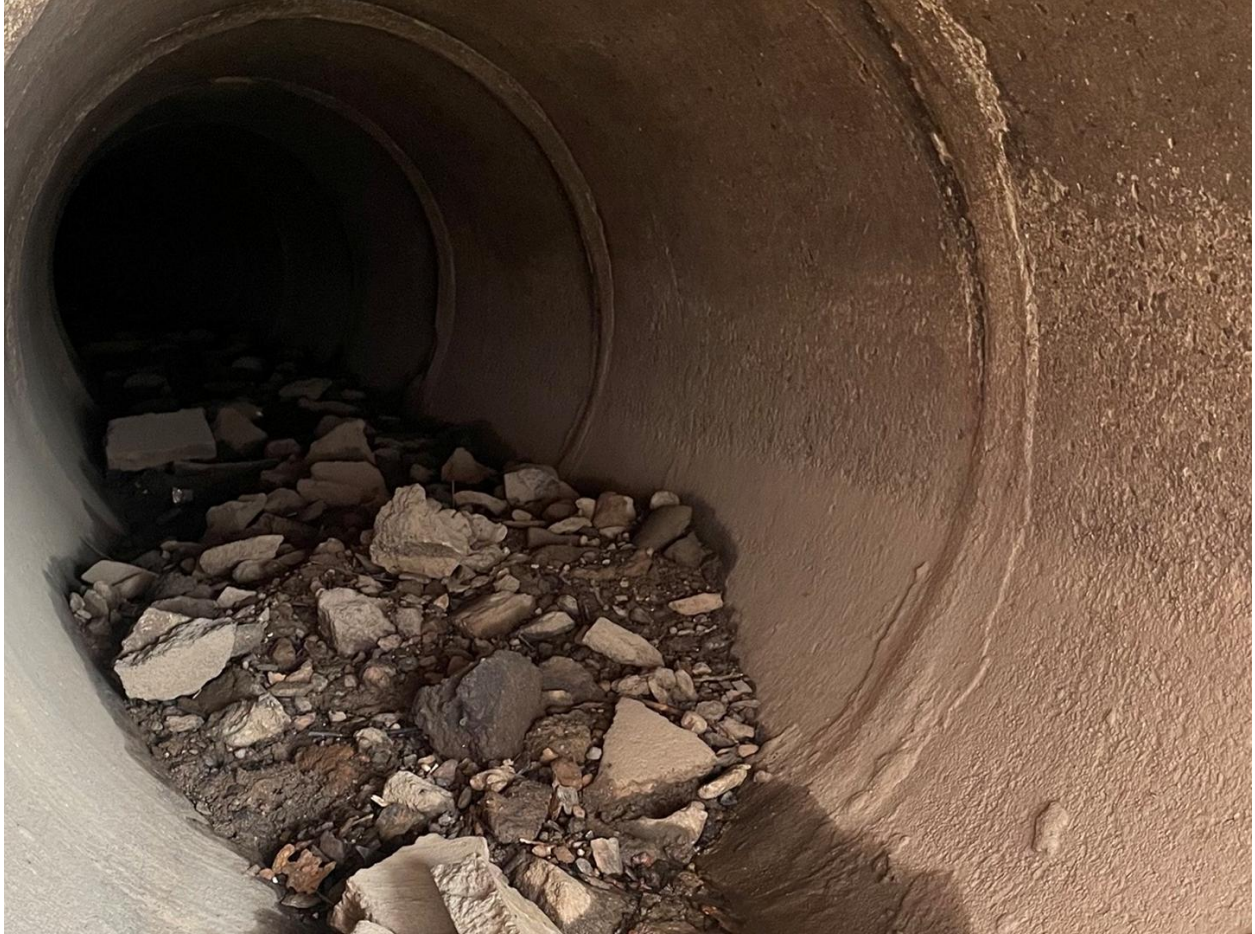
A few feet inside the Brandt Road Outfall to the East Ditch

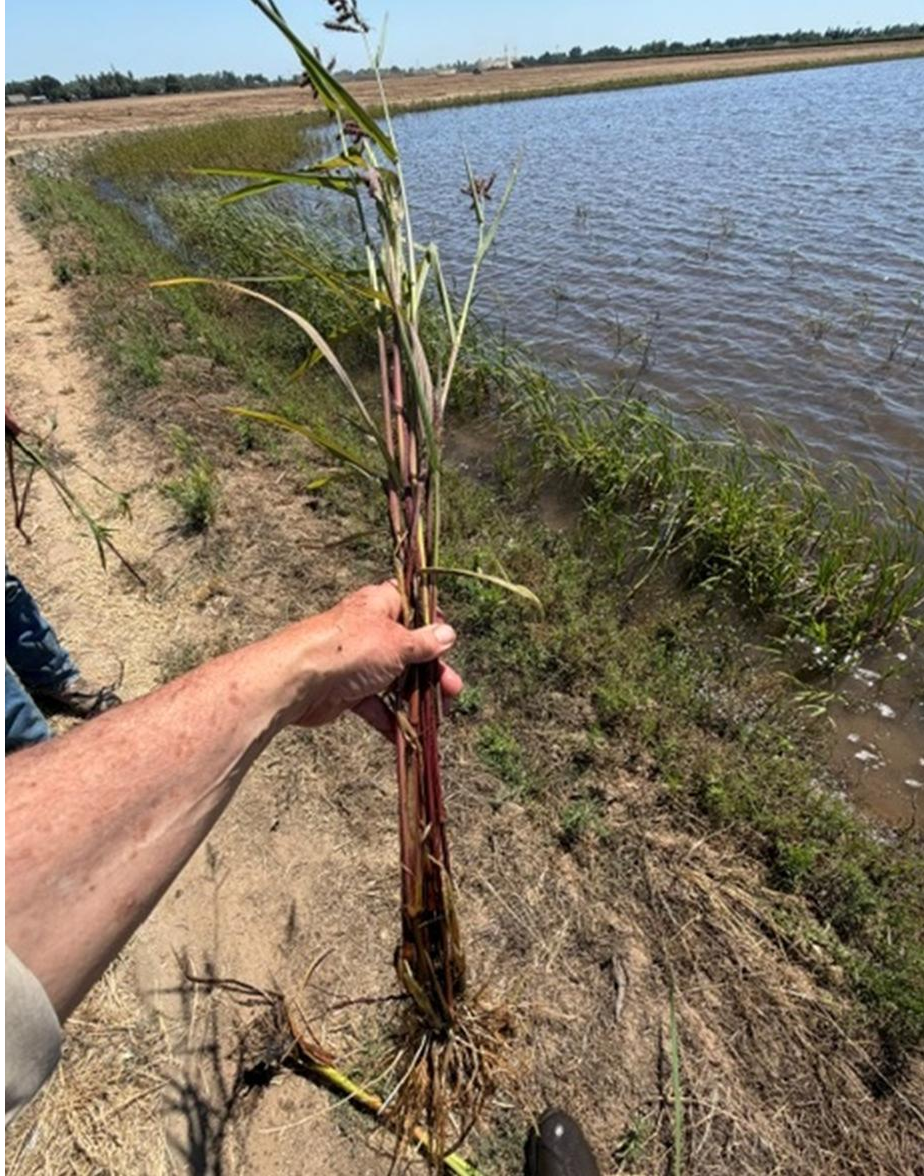
Lakso Basin: Staff noticed new and heavy weed growth inside Lakso Basin in the last few weeks. The weed looks similar to Johnson's Grass which is considered a noxious weed by many farmers. Staff is working to identify the grass and find a treatment if it ultimately is determined to be Johnson's Grass.

No Corms in this specimen but I probably should have dug it out!
