# North San Joaquin Water Conservation District

## Operations Update

Sunday, August 9, 2026

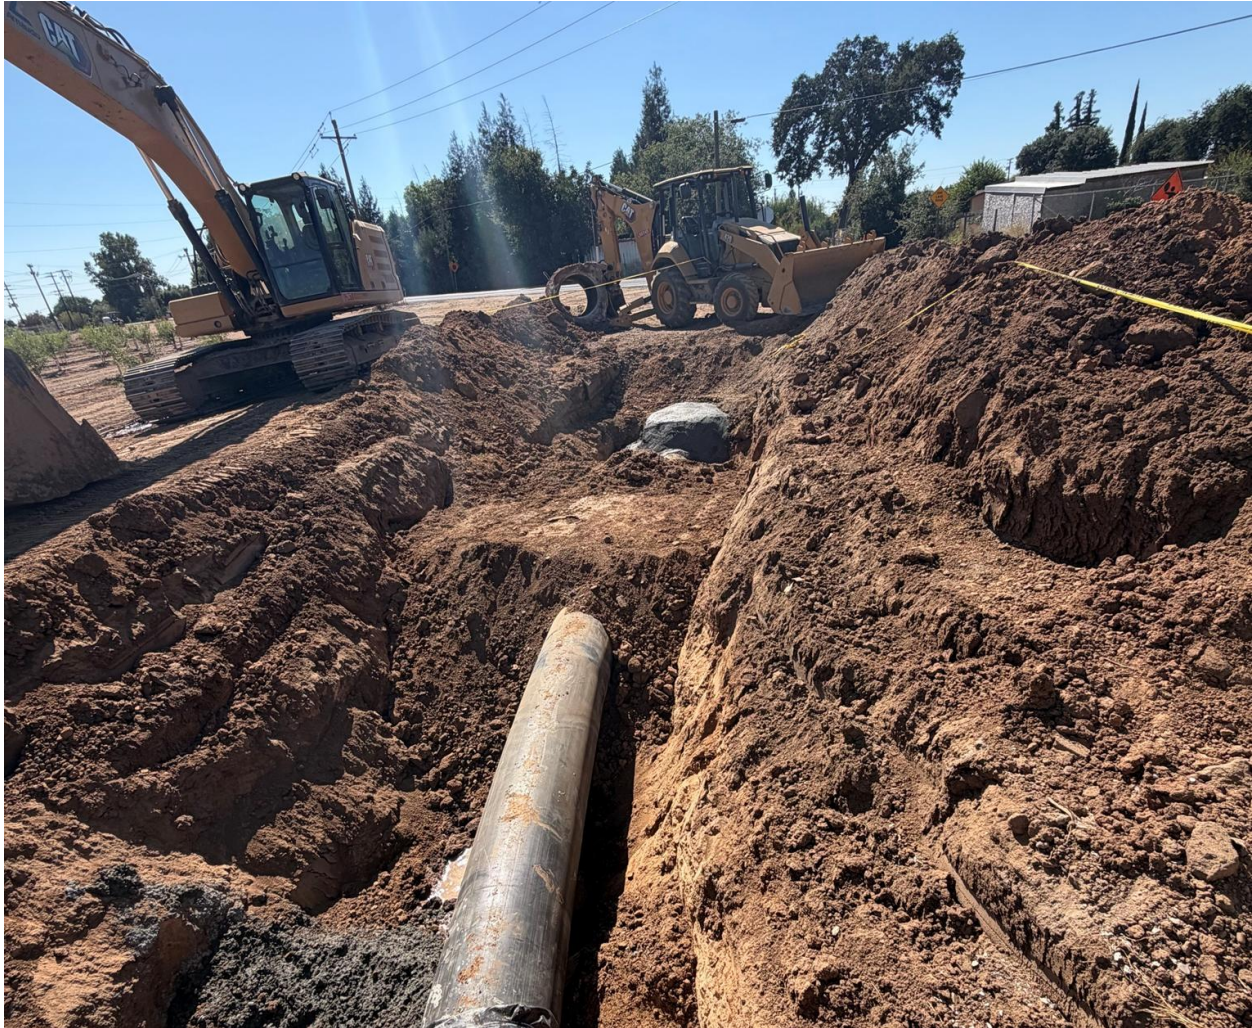
Brandt Road Lateral pipeline was able to make the curve without a 45 degree angle fitting

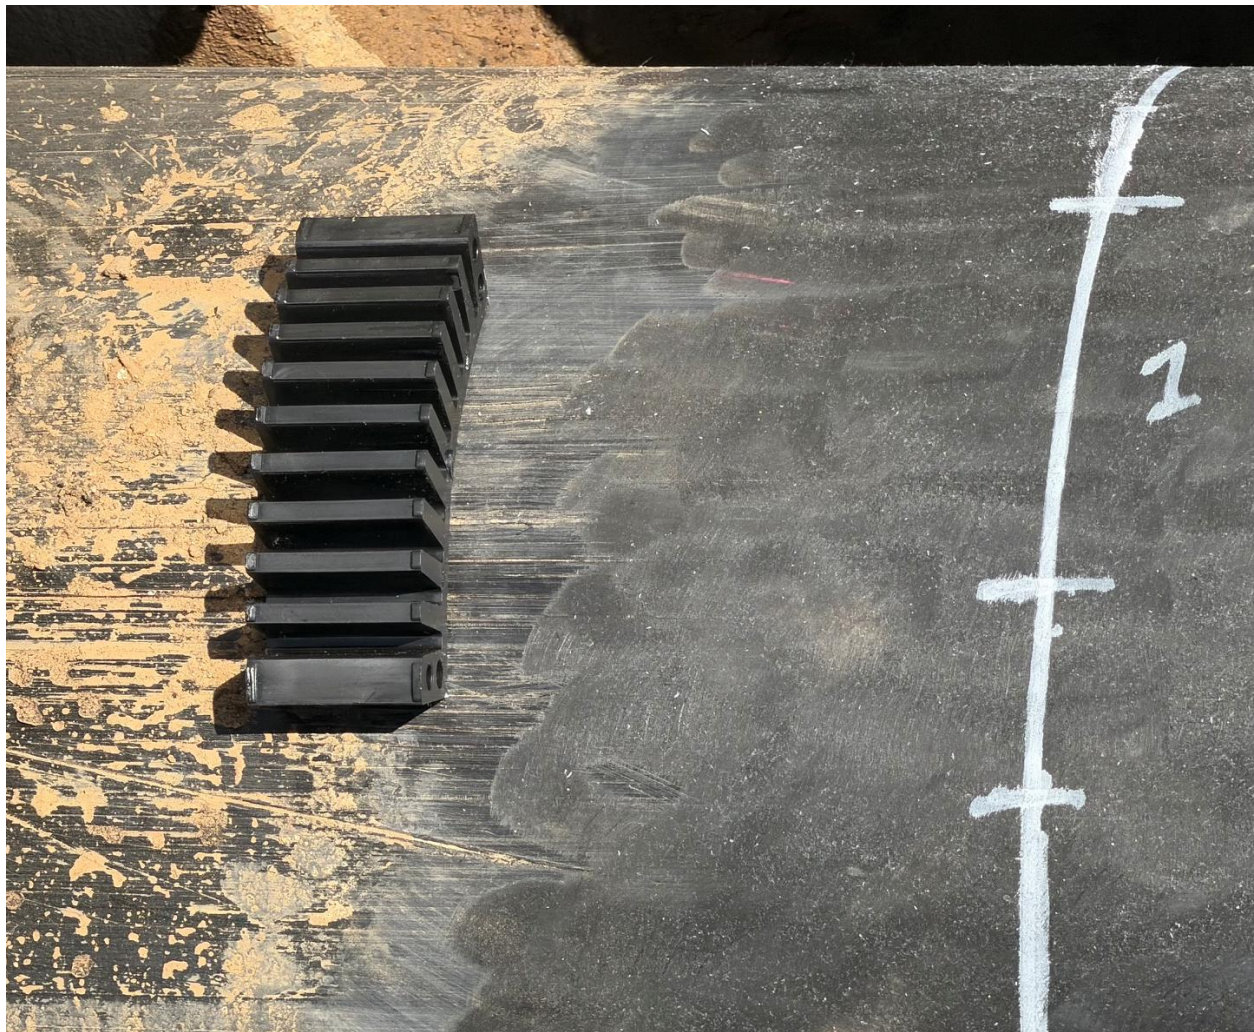
A large, dark, cylindrical object, possibly a pipe or container, is being secured with a metal band and bolts. The object is surrounded by dirt and debris, suggesting it is in a construction or excavation site. A roll of black tape is visible on the right side of the image.

PSWI welded bolts to the Brandt Road Lateral Pipeline before pouring concrete to hold the HDPE in place. Without the bolts the pipe would expand and contract over time and crack out the seal between the old and new pipe.

The Bolts for the Brandt Road lateral did not arrive in time but staff was able to source all thread and Arnaudo cut them to fit to avoid down time for the crew.

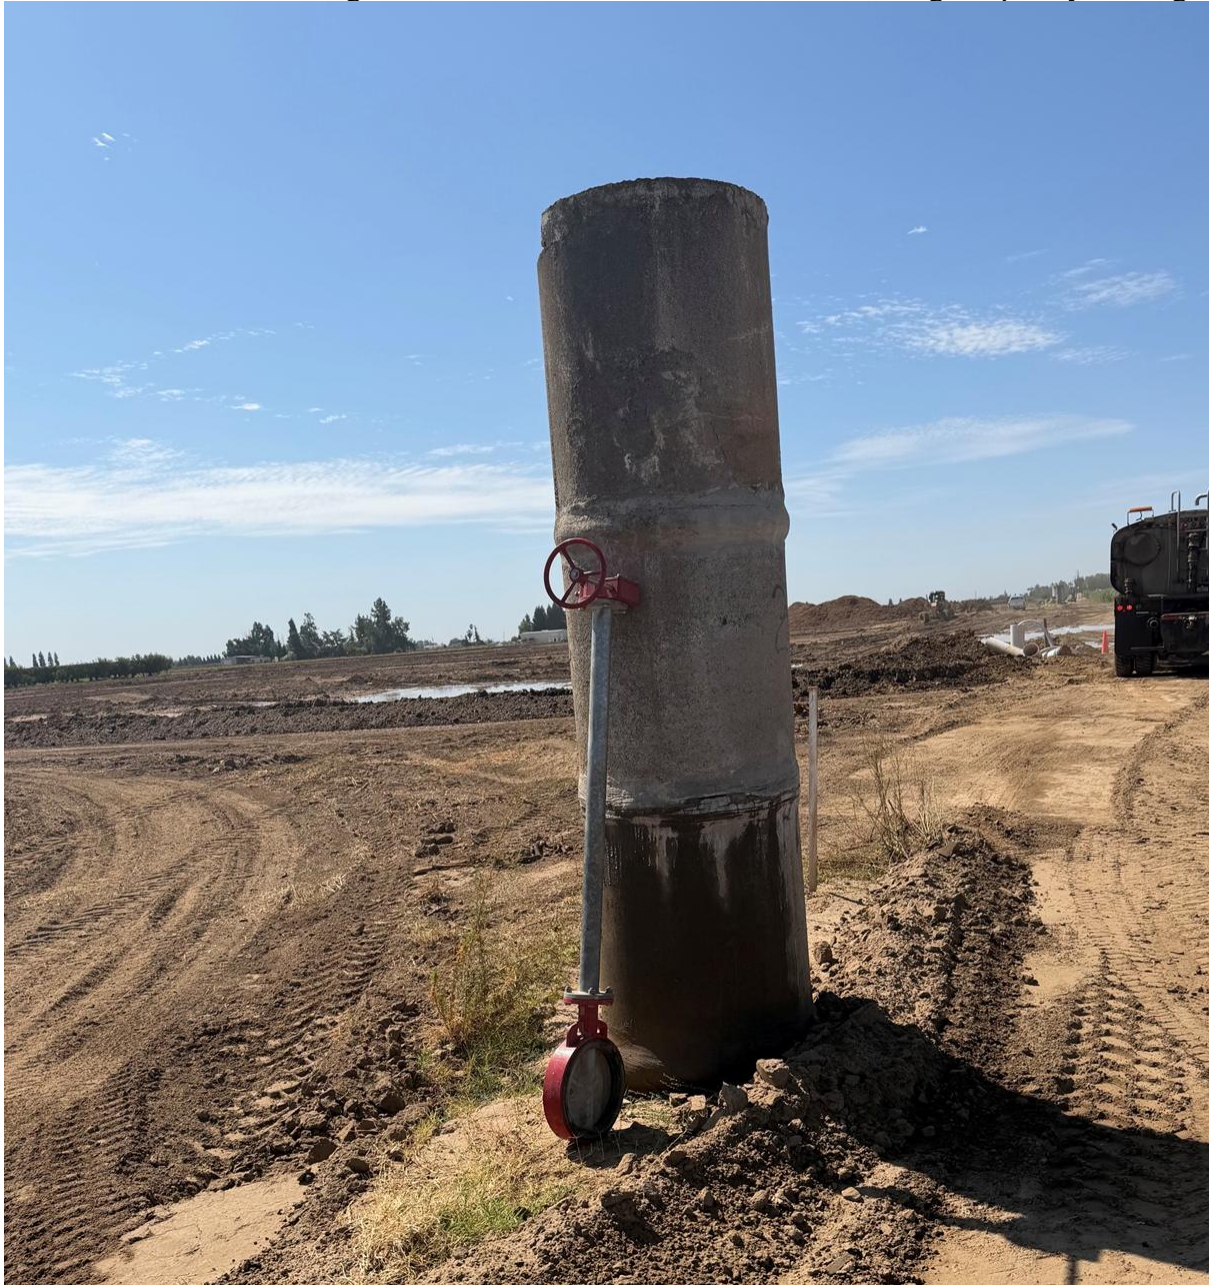
Rebuilt ten inch valve that was taken out of service at Lakso after being hit by a tractor

was able to rebuild a damaged ten inch valve that will serve the Goehring temporary recharge

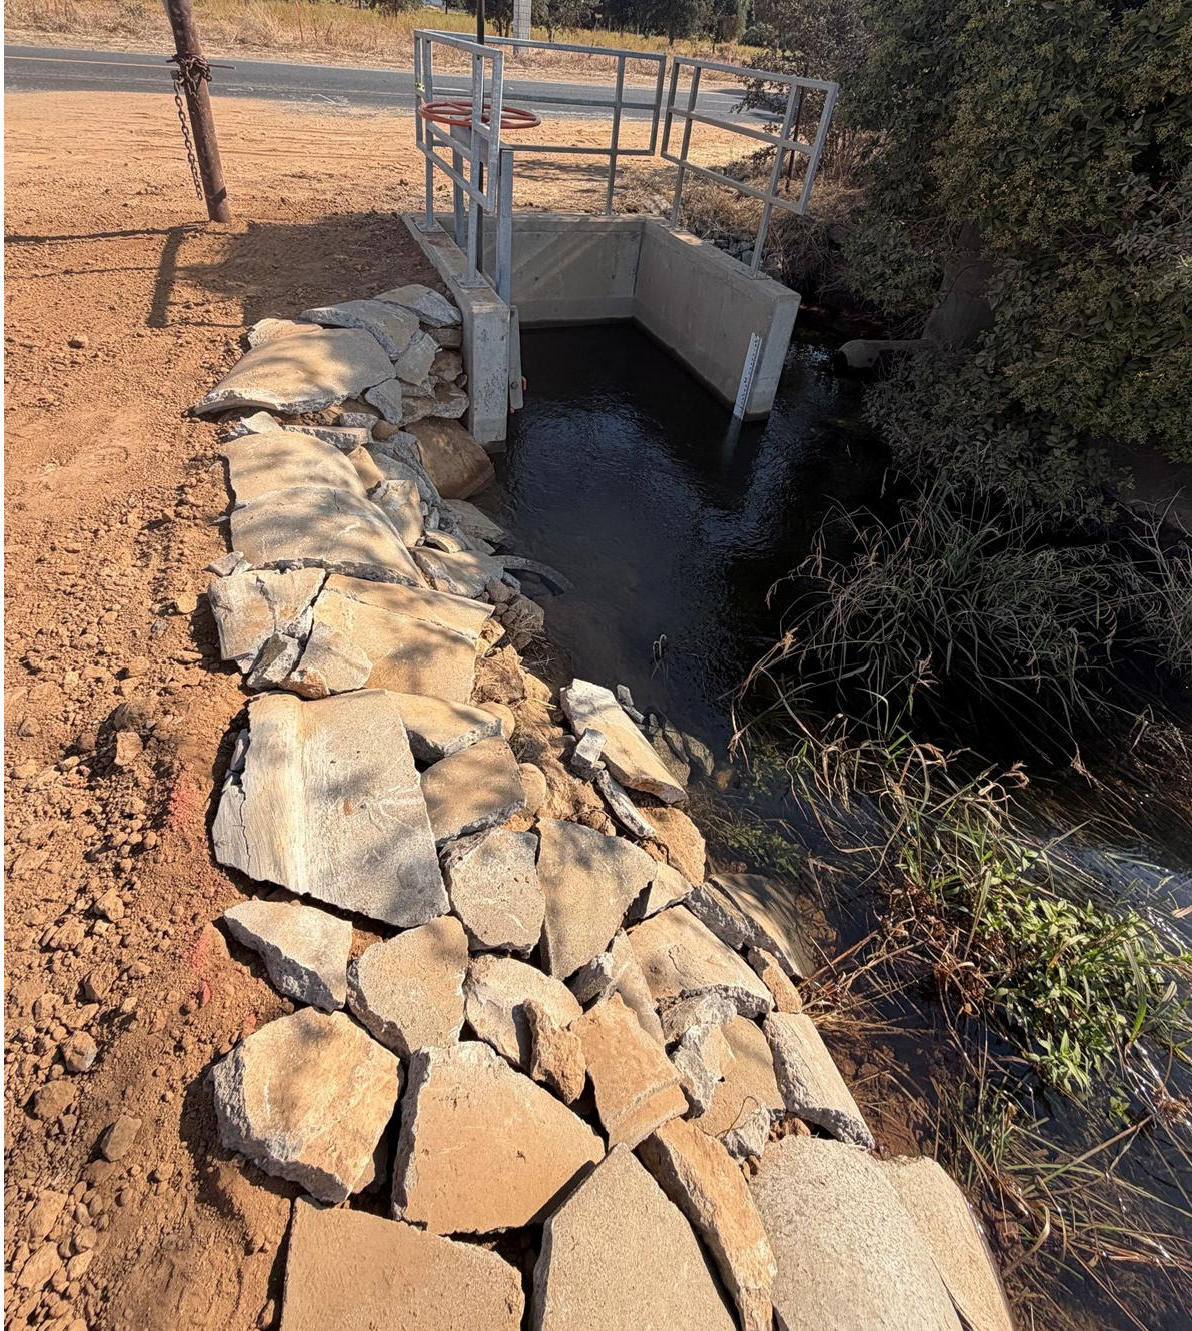
**Parting Shot:**

Staff asked Arnaudo to reuse some of the broken concrete to line the outfall to the East Ditch which had been undercutting the outfall wall
