North San Joaquin Water Conservation District

Operations Update

Monday May 23, 2026

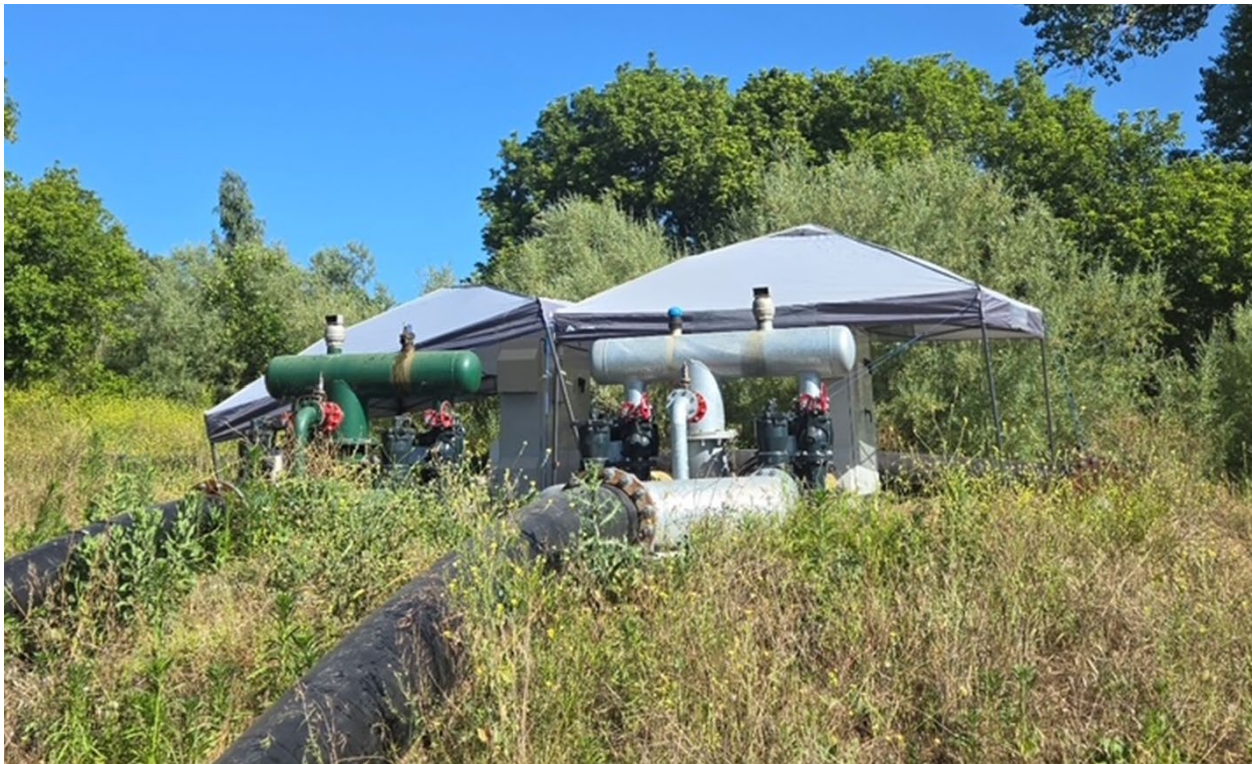
Operations Update: The north system ran flawlessly for most of the week. However, the heat on Thursday caused the VFDs on two pumps to exceed their rated temperature. As a result, the VFD derated two of the pumps and dropped overall flow rate down to about 4400 GPM from the expected 6400. Pacific Southwest responded and recommended temporary shade structures for the control boxes as a short-term solution. Staff installed two easy ups Friday morning and so far temperatures have remained below the de rating threshold. The pumps were at 6400 gpm yesterday afternoon and today. Pacific Southwest will prepare an estimate to install additional fans and more durable shade structures.

The shade structures have the added benefit of shading the operator

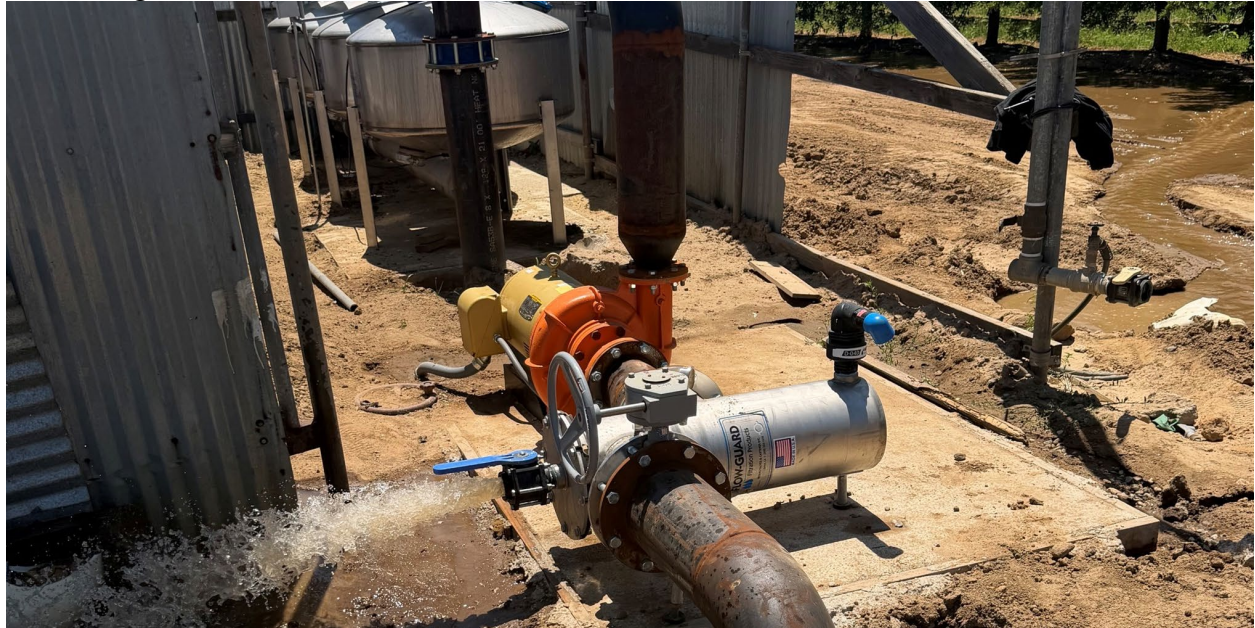
North System Irrigation: Creekside started up their SWEEP Grant funded surface water irrigation system on Thursday. It is likely the first surface water irrigation in the District on the North System in over fifty years. An exciting milestone. Staff has confirmed that at least two landowners on the north wish to join ID4 and staff will be securing signatures on the petition in the coming weeks.

Surface Water Flows into North System Irrigation Lines

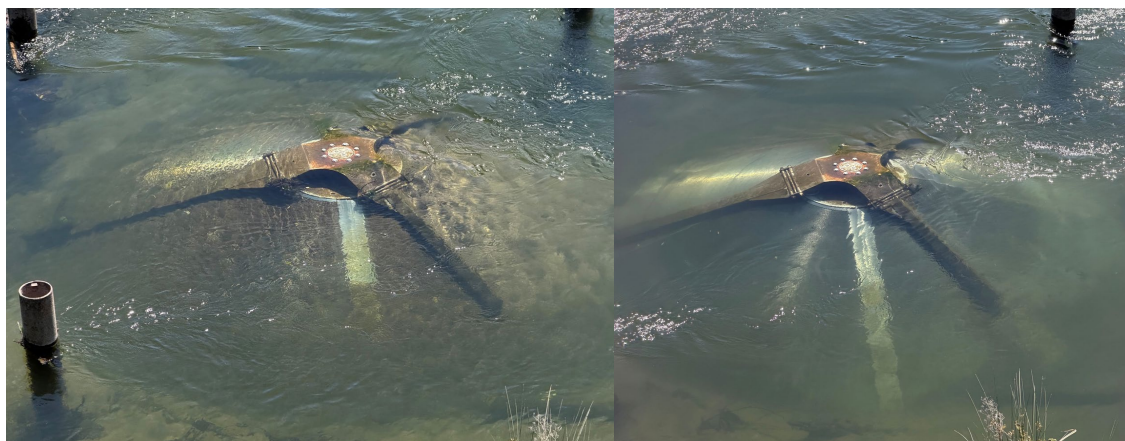
South System Work: The South System Fish Screen Stopped working some time this week. Staff found it when checking oil on Saturday. Staff contacted Russell Barry of ISI who will be out to inspect and if possible, repair tomorrow. In the mean time staff took a cool dip on a hot Saturday afternoon and swept the screen by hand with a pool brush. Arnaudo continues to re compact areas along the south system main. Staff is hoping they will be able to get to the four repairs needed high on the south main this week to allow higher flow rates to the south main and resolve leaks on the lateral that flows to the East Ditch.

South Screen before and after a hand cleaning

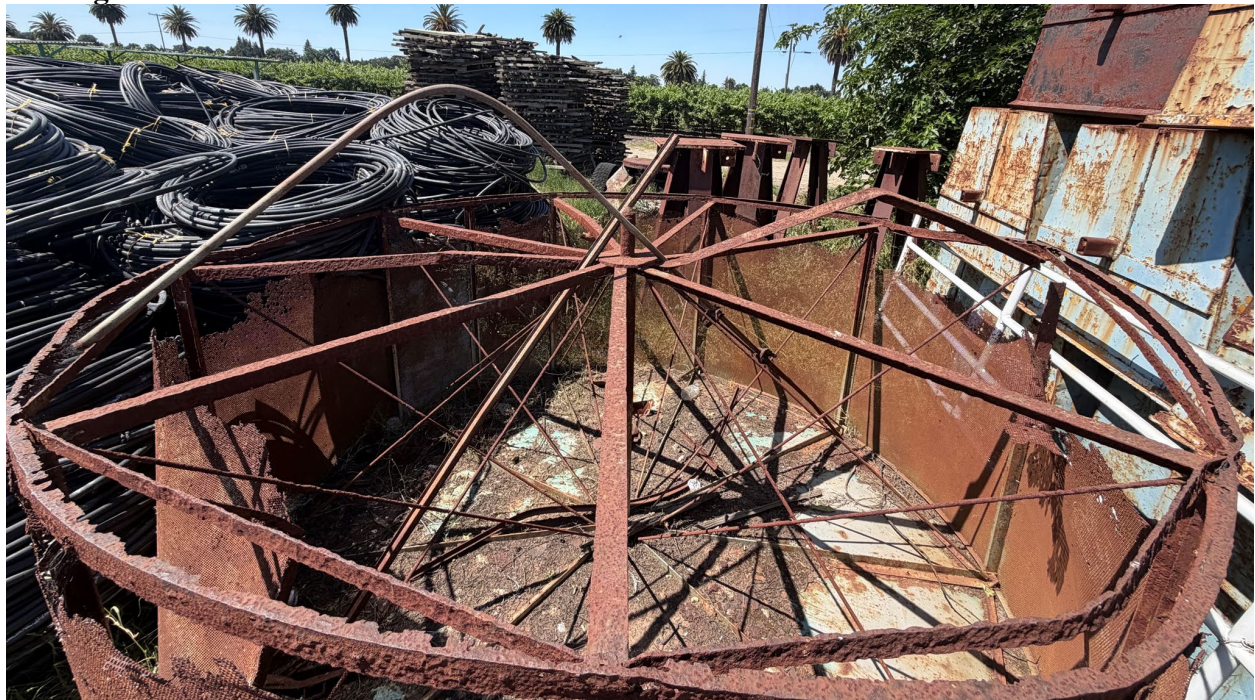
The original south system fish screen (or is it the falling chandelier from Phantom of the Opera) rusts in peace at Kautz Farms.
