North San Joaquin Water Conservation District

Operations Update

Saturday October 3, 2026

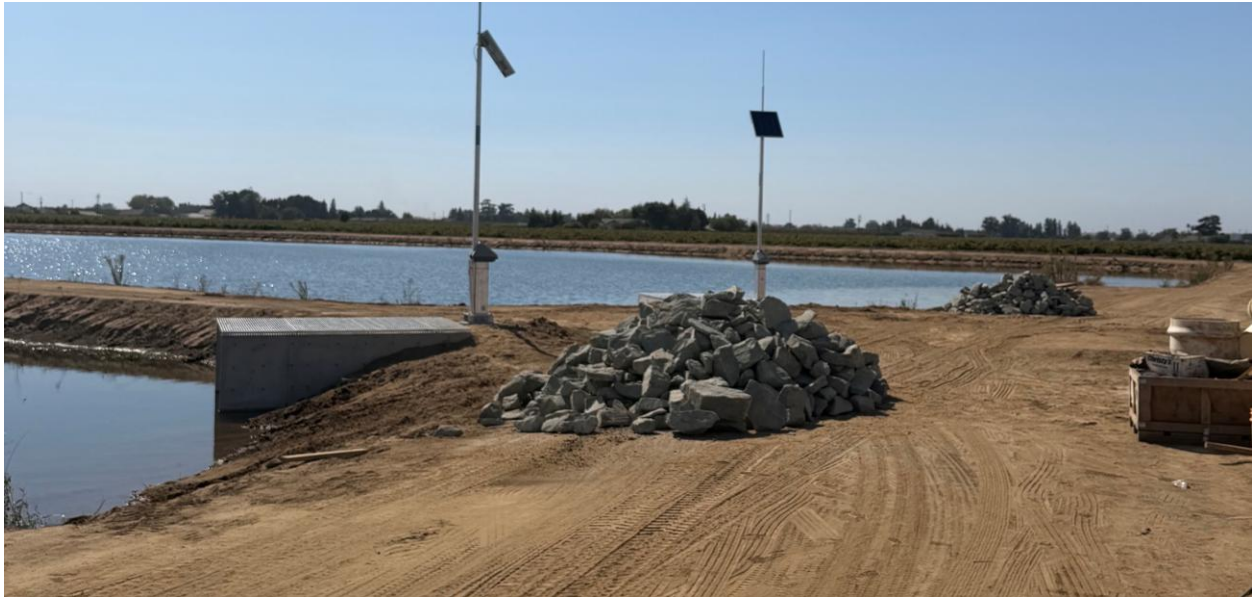
**Teck Basin Update:** Central Irrigation set the Rubicon meters and solar arrays (though they will need to be reset to face south.) Staff had rip rap delivered to place around the outfall once the Bobcat makes its way back to the basin.

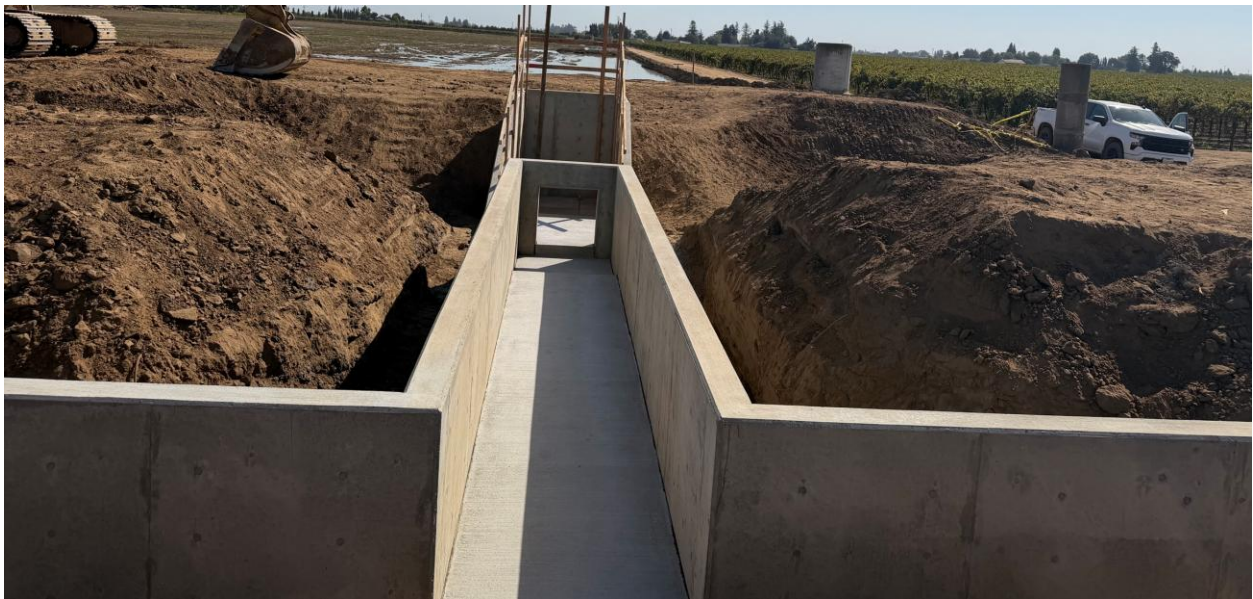
**Locust Tree Basin:** Arnaudo finished the intake structure except for the trash rack and back fill. They put a false floor in the bottom of the intake and a fence around the top to prevent anyone from falling in. The temporary Goehring Basin revealed compaction failures in the South System Phase 3 Project. We filled the first few but more developed over the course of the week so we asked Teichert to come investigate. We drove the entire alignment and only found issues by Goehring. Staff is concerned that Goehring may be revealing an issue that may extend further down the line.

The structure at the toe of Locust Tree basin under construction

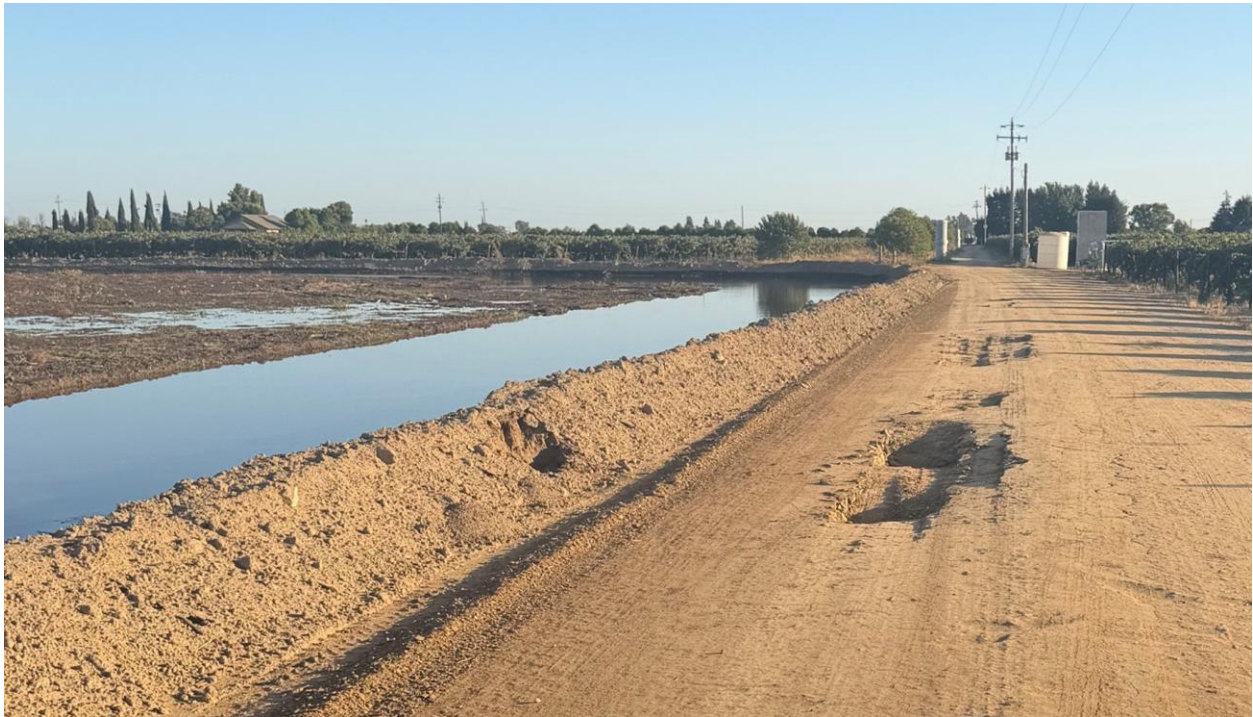
Compaction Failures developing in South System Phase 3 alignment
