North San Joaquin Water Conservation District

Operations Update

Saturday, June 27, 2026

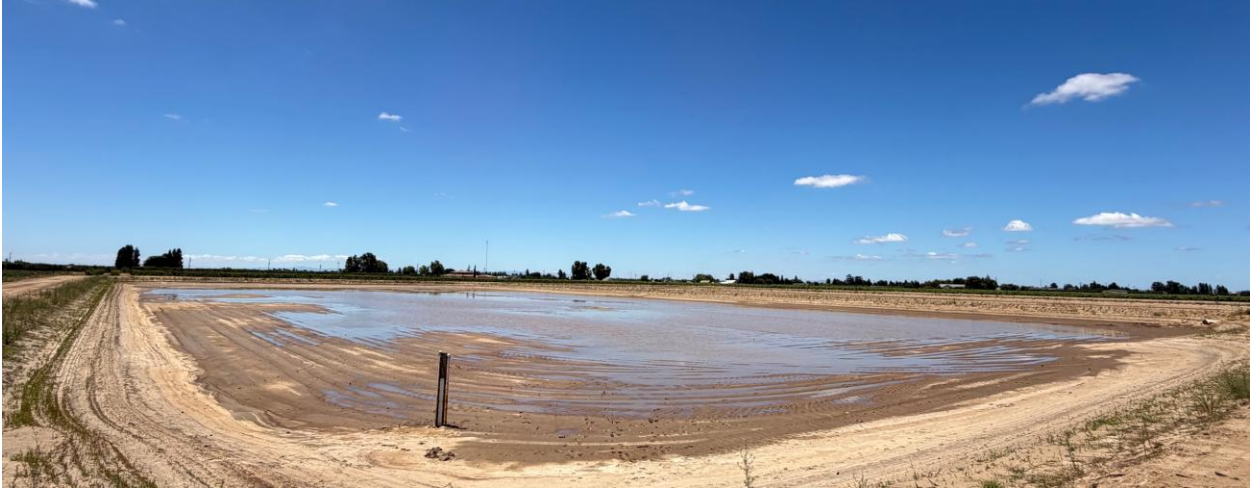
The Eastern side of Teck Basin is finally nearly dry!

Tecklenburg Basin: Arnaudo took a short break from South System Repairs to plug the pipeline that was connecting the two basins. Arnaudo's efforts allowed staff to finally pump the eastern basin mostly dry as seen in the first photo. Staff noted that the hole Arnaudo dug to disconnect the lines percolated very well dropping a good ten inches overnight: another sign that the primary issue driving down percolation at Teck Basin is storm water silt.

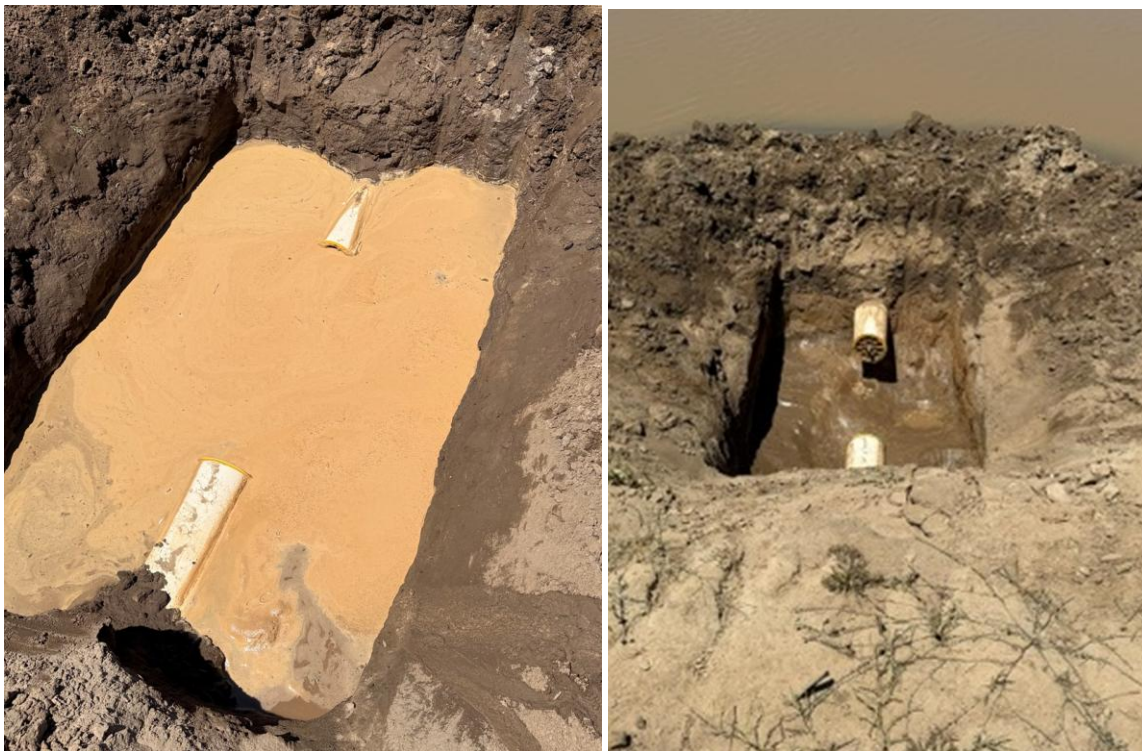
Now that the eastern and western basins are no longer connected staff has also noted that the Western basin is actually percolating better (about 1 tenth a day) than the eastern basin (effectively zero). Staff will begin pumping water from the western basin into the temporary south ditch on Monday in an effort to advance the construction timeline.

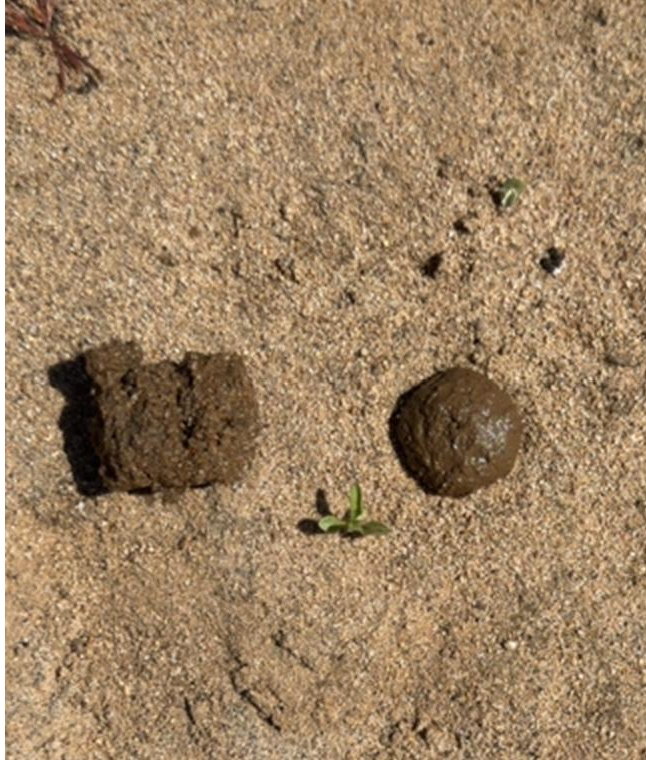
On the right is silt from the basin floor. On the left is sand just a few millimeters below the clay layer

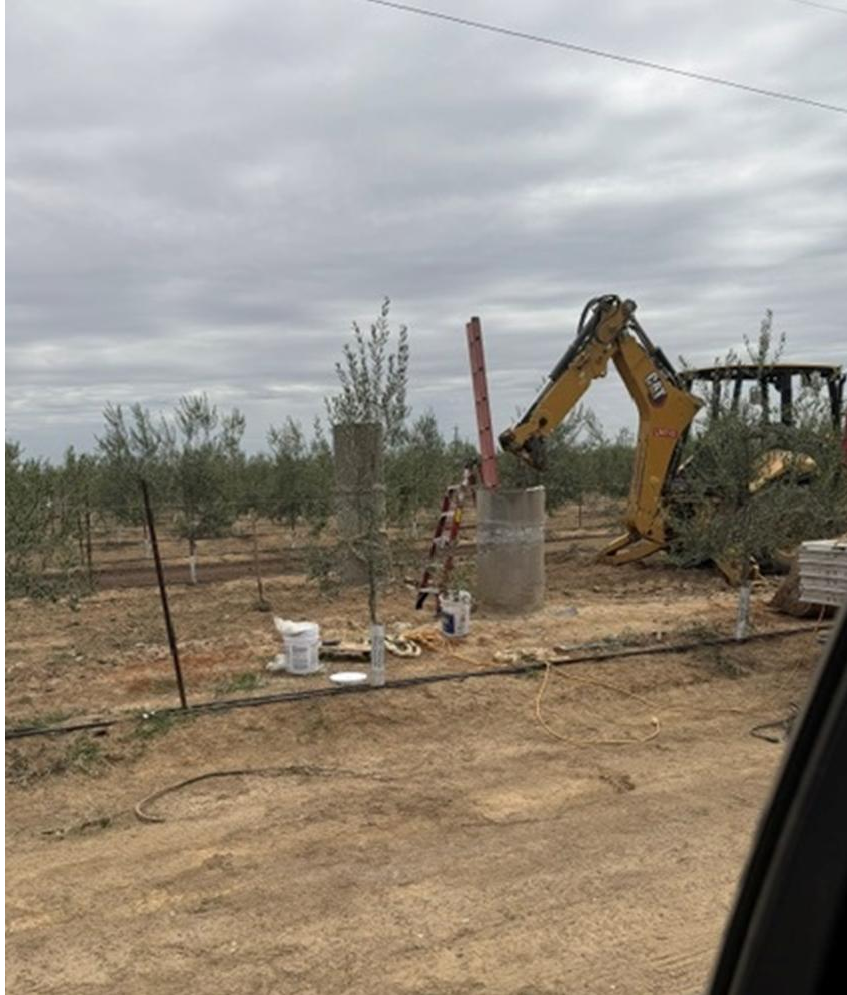
It's a pretty tight squeeze to repair the Tretheway Road section from inside

South System Work: Arnaudo poured a new collar for the Brandt Road air vent and sealed a few new leaks from the inside and sealed two new leaks on Tretheway Road from the inside. So far, the repairs are holding.
