North San Joaquin Water Conservation District

Weekly Update
Friday October 18, 2024

Costa Recharge Project Starts for the Season

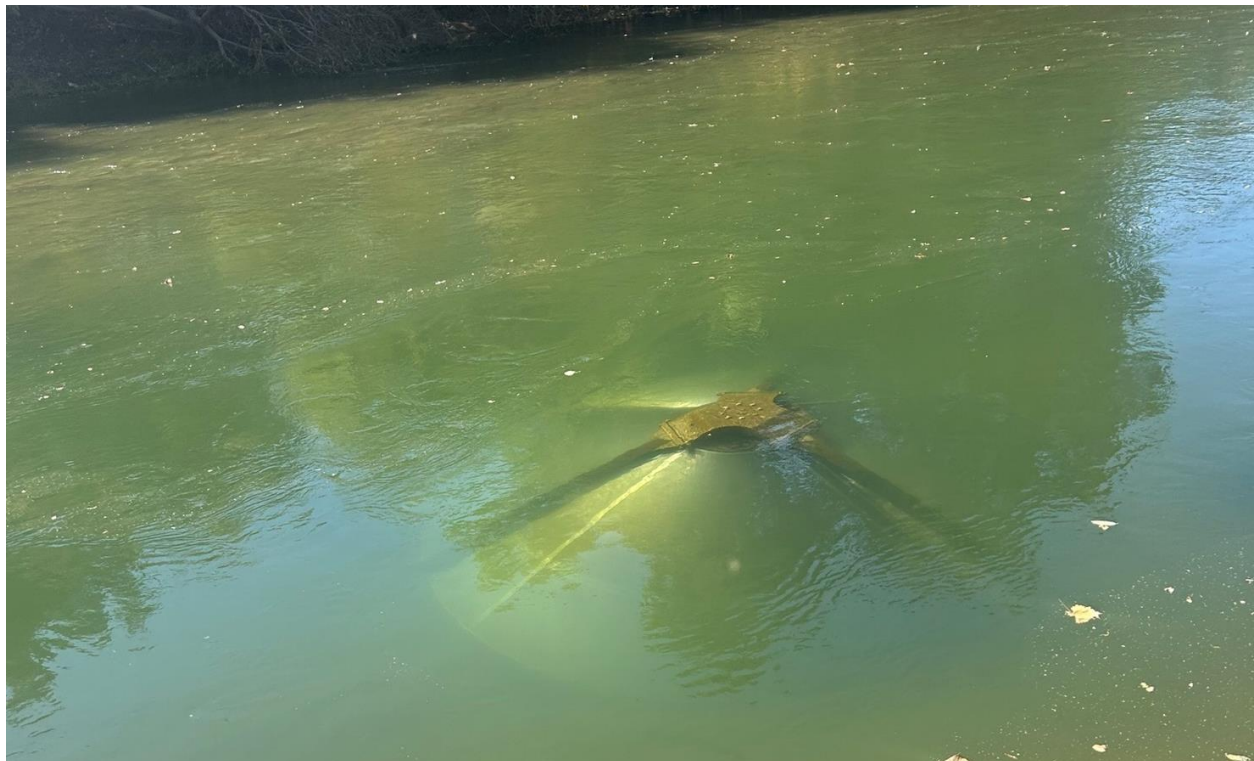
Tracy Lake Fish Screen

Staff was pleased to see the results of its fish screen sweep schedule after the fist pulse wound down today. The Tracy Lake screen which is typically hit the hardest by sand is still clear after the first pulse. Cal Fed, South Station and North Station are all clear of sand as well.

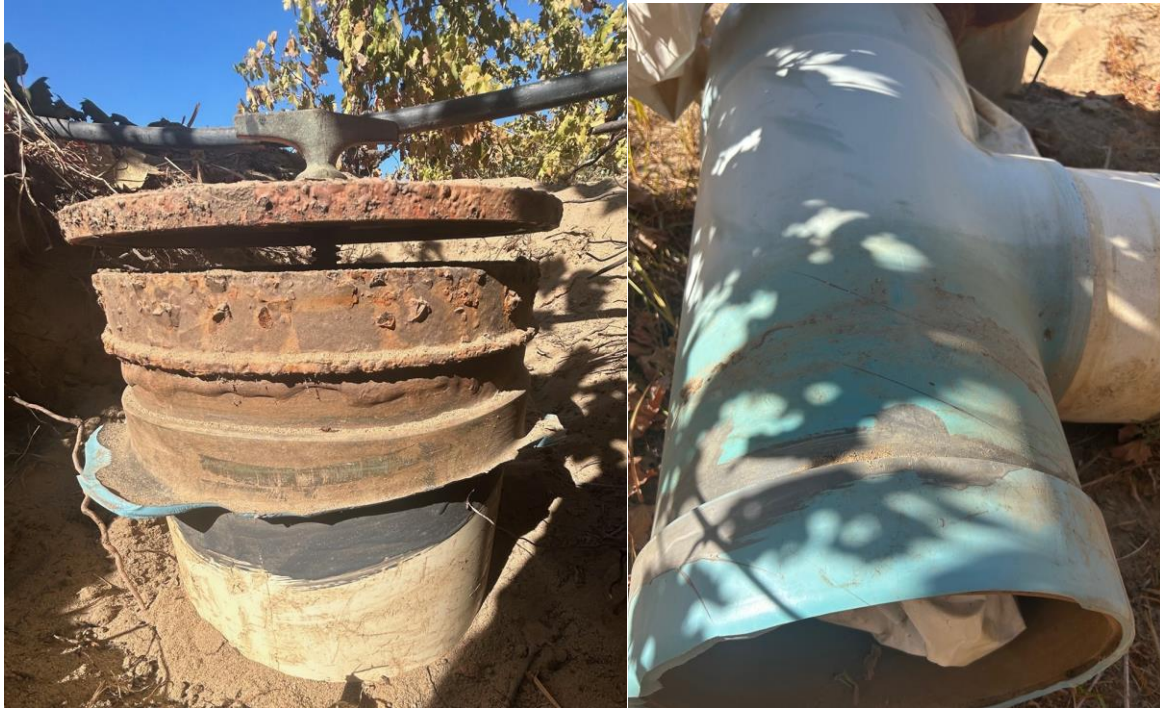
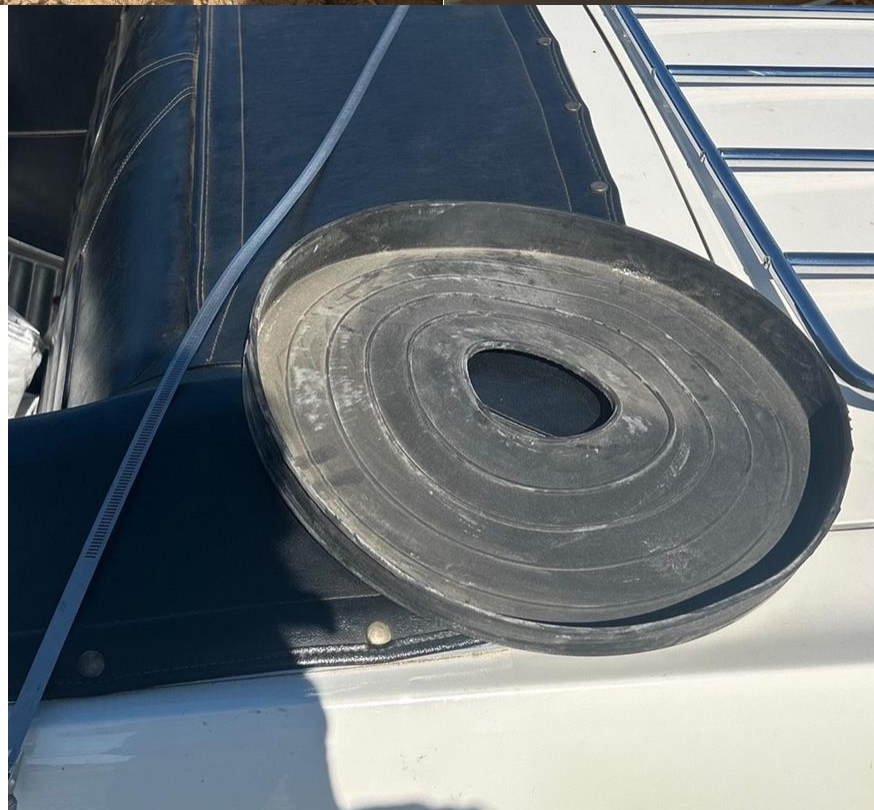
After some hiccups Costa got started Thursday evening. The Costa system is operated by six hydrants that cover an alfalfa valve. The hydrant closest to the river was broken off by an unknown cause. A happenstance discussion with Steve Borra who has experience with these systems revealed a relatively easy fix. Staff installed a large \$40 gasket under the valve, cut off the broken portion of the hydrant and

The gasket used to repair the hydrant. The hole was stretched over the alfalfa valve and the lip was placed around the hydrant and then strapped down to the hydrant.

banded the hydrant to the gasket. Contract staff is installed the berms and started the pump yesterday at 5 CFS.
